Tackling damp and improving thermal performance at heritage cottage

Cork Render Finish (2nd Coat still to be applied) llias Igoumenidis from Ecological Building Systems discusses how thermal plaster has helped to transform a derelict 19th century cottage in the Cumbrian village of Allonby into a desirable holiday retreat.

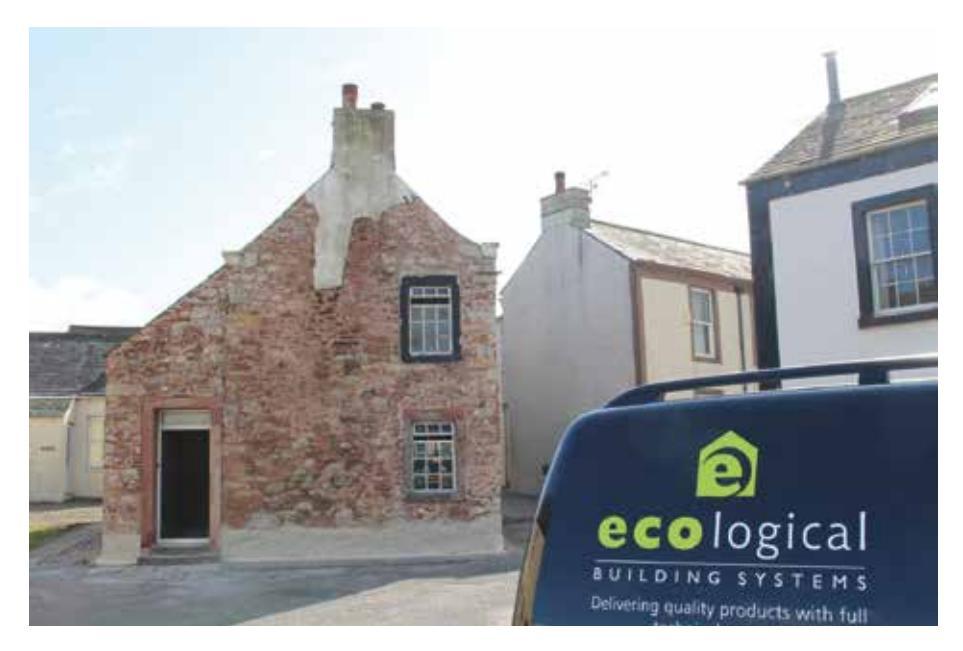
Top: Existing cement render was removed from the sandstone rubble walls

Externally, stripping back the mouldy and discoloured render revealed rubble sandstone which was cleaned to remove any loose particles. The naturally rough surface provided an ideal key for application of the plaster. For the timber lintels and window surrounds, however, Diasen Aquabond was used to aid adhesion of the Diathonite Evolution.

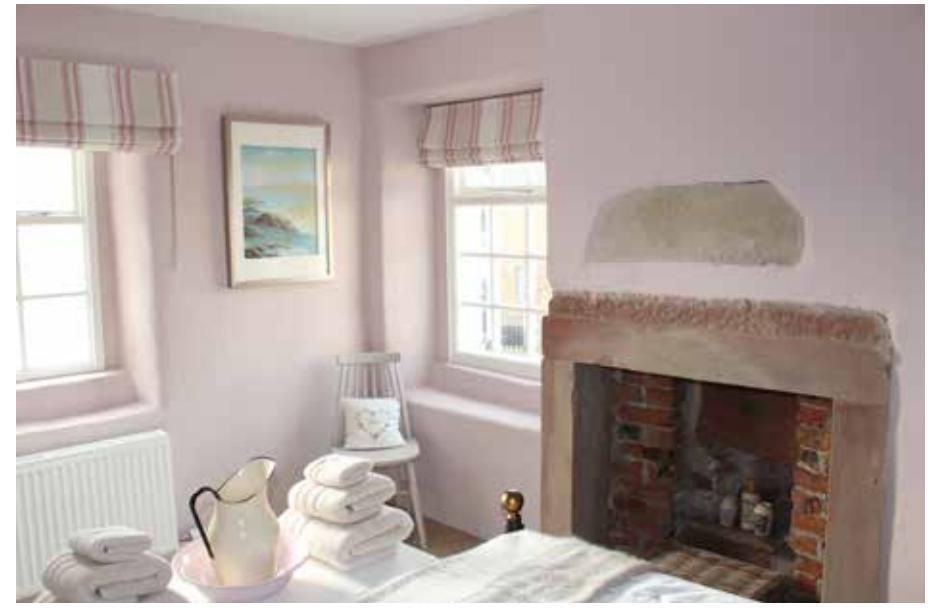
Middle: The Diasen system enabled the cottage to keep its characteristics

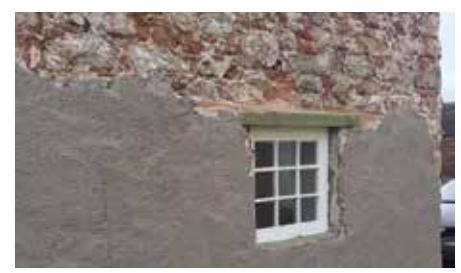
Bottom right: Diathonie Evolution applied to the external rubble wall

The Diathonite Evolution was hand-applied to the external walls, with the grey of the wet thermal plaster gradually turning to white as each surface dried.

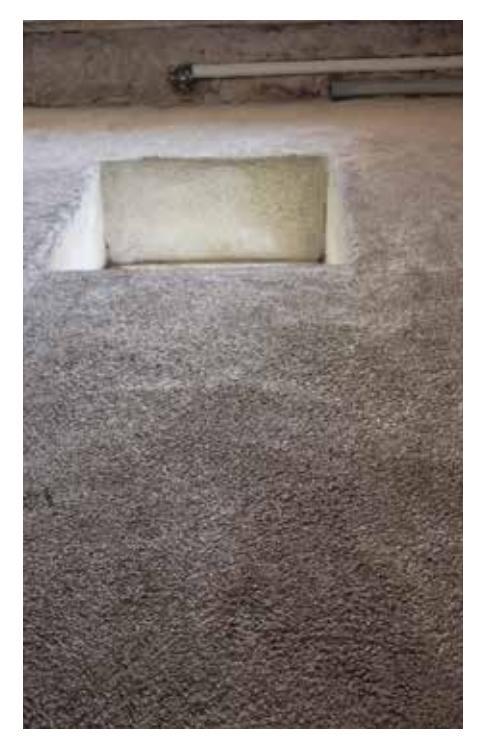
Left: Diathonite Evolution was floated

The Diathonite Evolution was spray-applied in two 25mm layers and this was then floated by hand to provide a smooth internal wall surface, following the contours of the original walls.

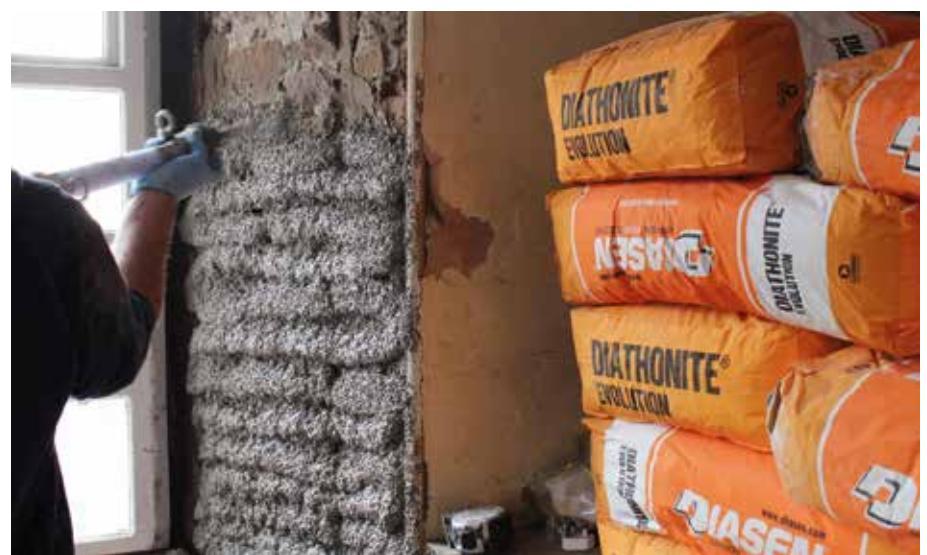
Left: Diathonite Evolution was spray applied internally *Right:* The walls were finished with

a natural paint
